FORM & FUNC

DURABLE FLOOR SYSTEM, TURBINE REPAINT HELP UPDATE POWER PLANT

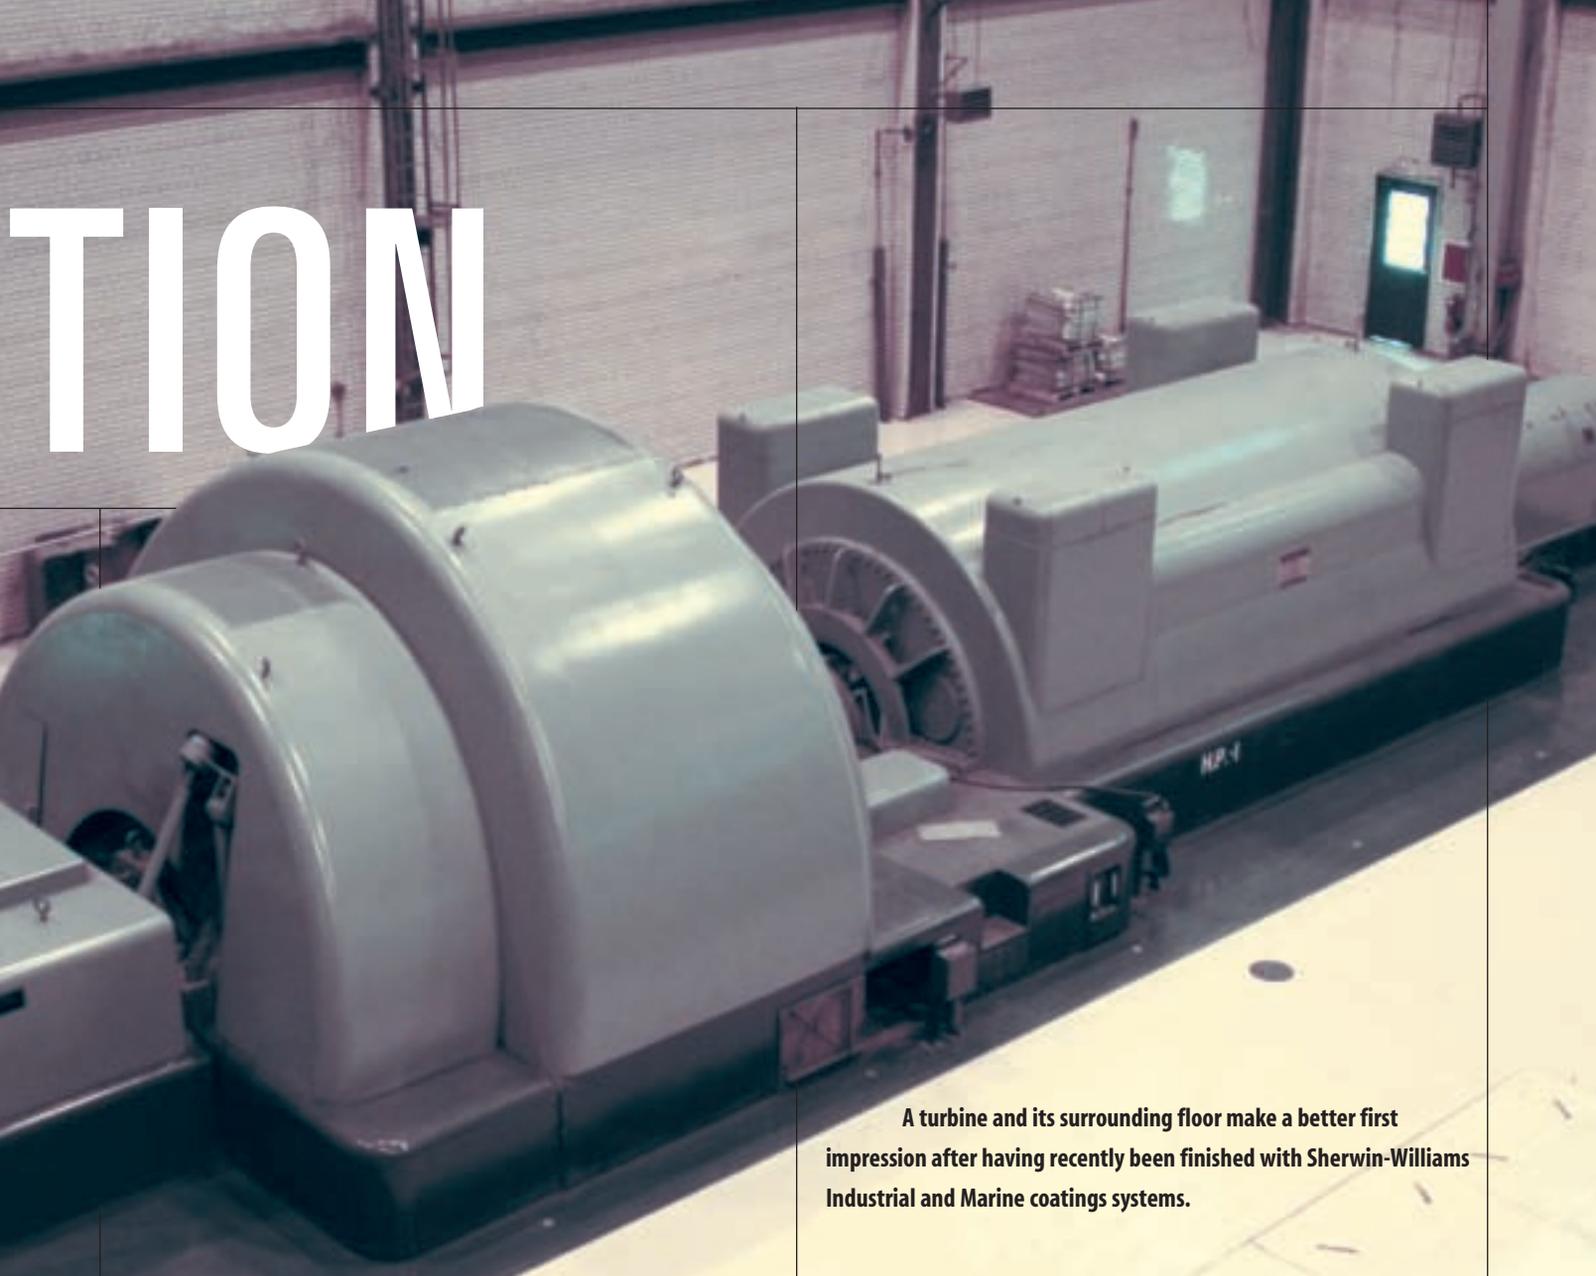
A turbine and its surrounding floor make a better first impression after having recently been finished with Sherwin-Williams Industrial and Marine coatings systems.
